Inspection Date:	April 29, 2021	A#:	0603142
Client:	Blackspur Oil Corp	National Board #:	N/A
District:	Beaverdam	Owner Asset #:	V-2020
Facility/Area:	Gemini Oilsands Project	Equipment Description:	Crude Emulsion Treater
Surface Location:	2-14-060-03W4	Manufacturer:	NATCO
Bottom Hole Location:	N/A	Manufactured Date:	2011
Vessel Volume (m3):	N/A	Manufacturer's Serial #:	9265
Equipment Orientation:	Horizontal	CRN #:	V 3196.2
Equipment Length/Height:	40'	QTI Identification #:	N/A
Equipment Outside Diameter:	8'	MAWP:	517 kpa @ -29 °C
Shell Thickness:	0.375"	MDMT:	-29°C @ 517 kpa
Shell Material:	SA51670N	Corrosion Allowance:	0.0625"
Head Thickness:	North Head - 0.3125" South Head – 0.500"	PWHT:	No
Head Material:	SA51670N	RT Level:	RT-3
Suitable for Continued Service:	Yes		
Recommended Insp Interval:	5 Years	Construction Code:	ASME Sec VIII Div 1 2007 Edition
Inspector's Qualifications:	API 510/570, ABSA IPV, CWB	Inspector's Name / Signature:	Cody Hankinson

Inspection Type:	External <input checked="" type="checkbox"/> Internal <input checked="" type="checkbox"/> NDE <input checked="" type="checkbox"/>	NDE Type:	UT Thickness Survey
SUMMARY:

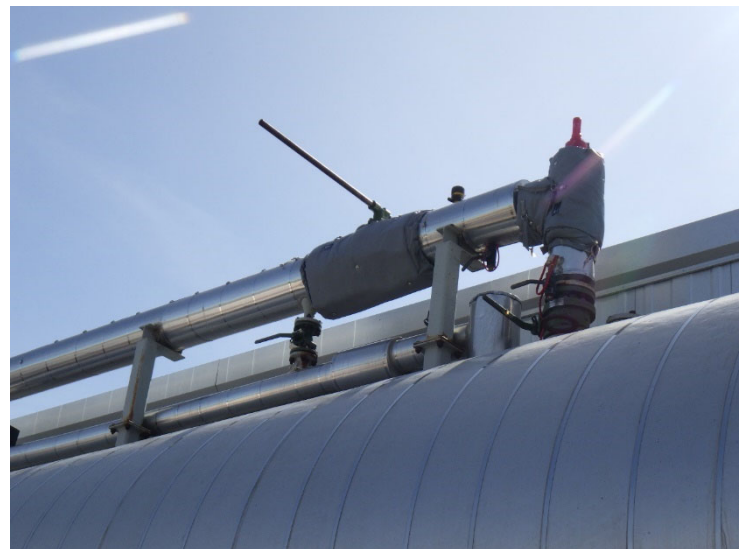
PSV – not accessible

Item	Description	Communicated to	Date:
PSV Access 1	PSV not accessible. Must ensure proper protection before use.	Kevin Saizew	May 02, 2021
Anodes 2	Some degradation. Recommendation: Replace with new anode.	Kevin Saizew	May 02, 2021
3	1 year UT survey to establish short term corrosion rate under the vessels new service conditions.	Kevin Saizew	May 02, 2021
4			
5			
6			
7			
8

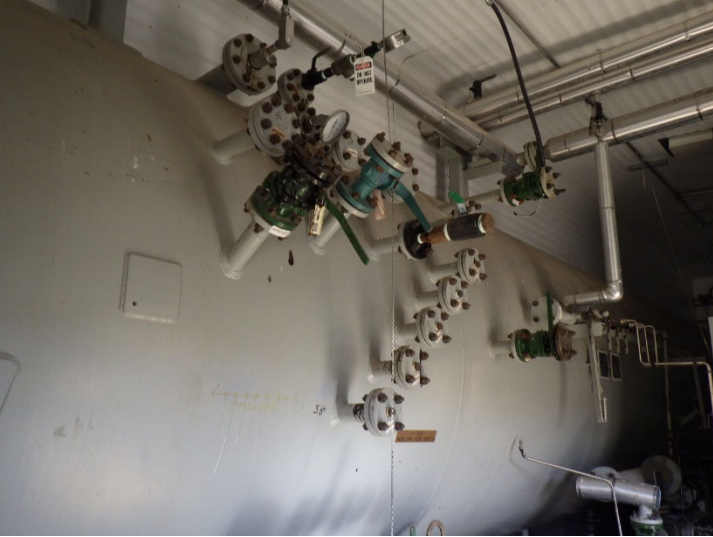
<p>Nozzles</p>

UT thickness Survey was completed during inspection. Could not access either head. All the shell readings were at or above nominal. CML 20, 25, 35, 55, 60, 70, 75, 85, 90, 95 all have one or more reading below nominal. All these CML points are on the nozzles. Please see attached UT report for further information.

Recommendation is to conduct a 1-year UT survey to establish short term corrosion rate under the vessels new service conditions (sour).
