EMERALD BOILER AND PRESSURE VESSEL INSPECTIONS INC.
PRESSURE VESSEL INSPECTION REPORT

COMPANY DATA			
COMPANY	Lightstream Resources	DATE	February 12 2014
FACILITY	North Handsworth	LSD	05-05-11-07 W2M
COMPANY TANK IDENTIFICATION #

VESSEL DATA											
DESCRIPTION	Vertical treater					MANUFACTURER	Natco				
MFG. DATE	1982					NB#/A#/S#	A#191798				
SERIAL #	L-6-251					CRN#	D781.21				
DIAMETER	6'					LENGTH	27'				
UNIT NUMBER						INSP. METHOD					
MAWP SHELL	50 <input type="checkbox"/> kpa	<input checked="" type="checkbox"/> psi	@ Temp 200	<input type="checkbox"/> C	<input checked="" type="checkbox"/> F	MDMT	<input type="checkbox"/> C <input type="checkbox"/> F	@	<input type="checkbox"/> kpa <input type="checkbox"/> psi		
MAWP TUBE	<input type="checkbox"/> kpa	<input type="checkbox"/> psi	@ Temp	<input type="checkbox"/> C	<input type="checkbox"/> F						
PSV INFORMATION <input type="checkbox"/> N/A 2ND PSV <input type="checkbox"/> N/A											
MANUFACTURER			LOCATION			MANUFACTURER			LOCATION		
SERIAL #			CRN #			SERIAL #			CRN #		
MODEL #			PSV #			MODEL #			PSV #		
SET PRESSURE			CAPACITY			SET PRESSURE			CAPACITY		
INLET SIZE			OUTLET SIZE			INLET SIZE			OUTLET SIZE

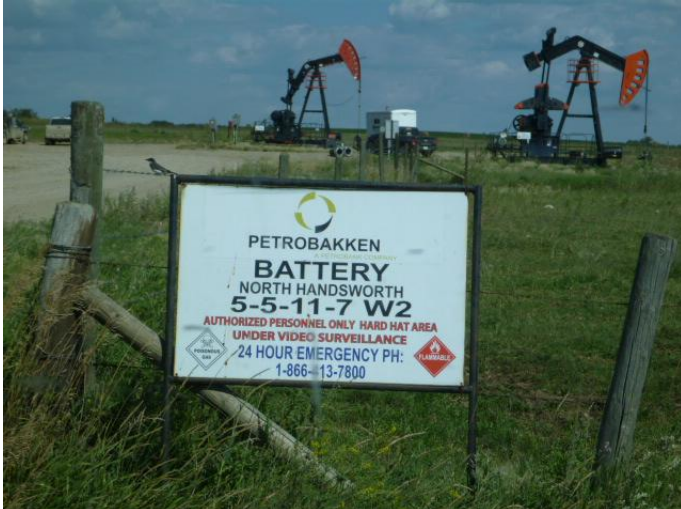
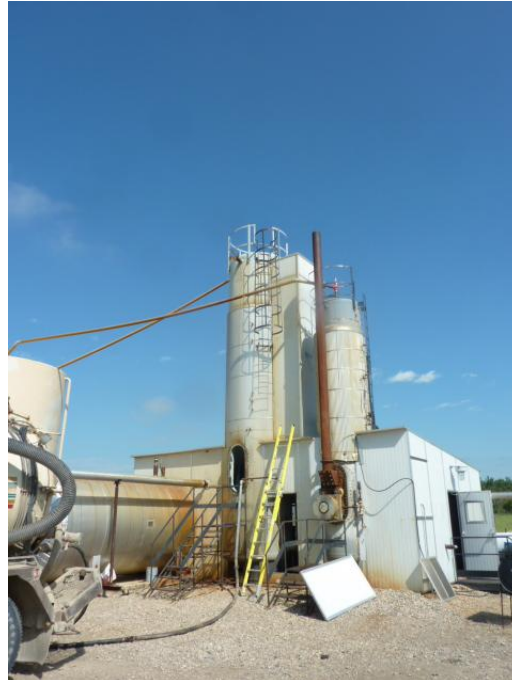
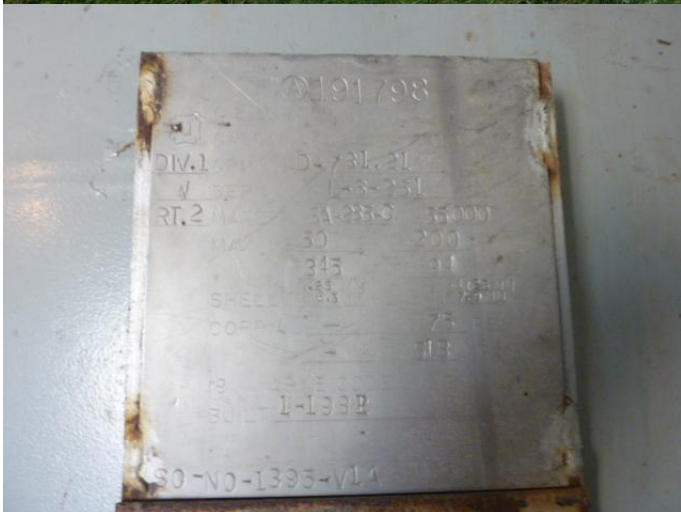
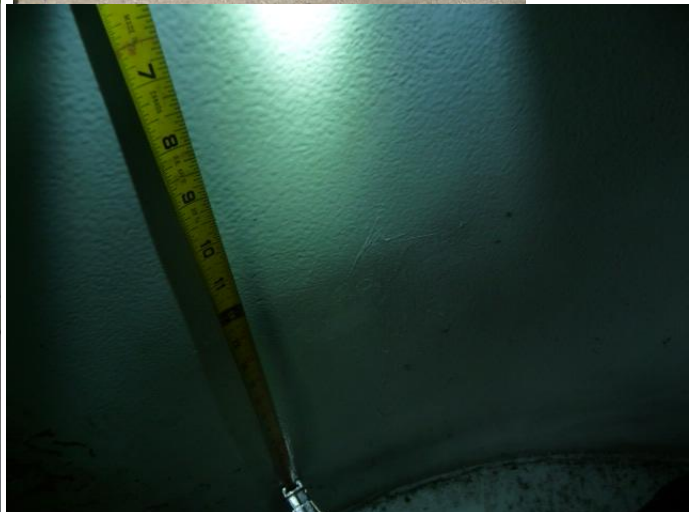
An internal/external inspection was completed on a bulged section of the shell in the water section along the building interface. This inspection was completed due to operator noticing this bulge and not remembering it being there before. Treater was clean for inspection.

Section has been coated; coating is in good condition with no signs of failure. At the bulged areas there is no signs of coating cracking or peeling.

UT completed by myself and Sonar inspections shows no signs of laminations or hydrogen blisters in this area of concern.

Bulge was caused by weld repairs conducted at the last turnaround on this treater before internal coating.

Externally the paint is burnt at the lacewelded areas. No visible cracks noted on the shell at the affected bulged area.

Bulged lower shell was the paint is burnt off shows no visible defects and was caused by weld repairs conducted in the past.
